JSC/White Sands Test Facility Safety & Health Program

WSTF Large Altitude Simulation System (LASS) Mishap

September 11, 2003

WSTF LASS Mishap

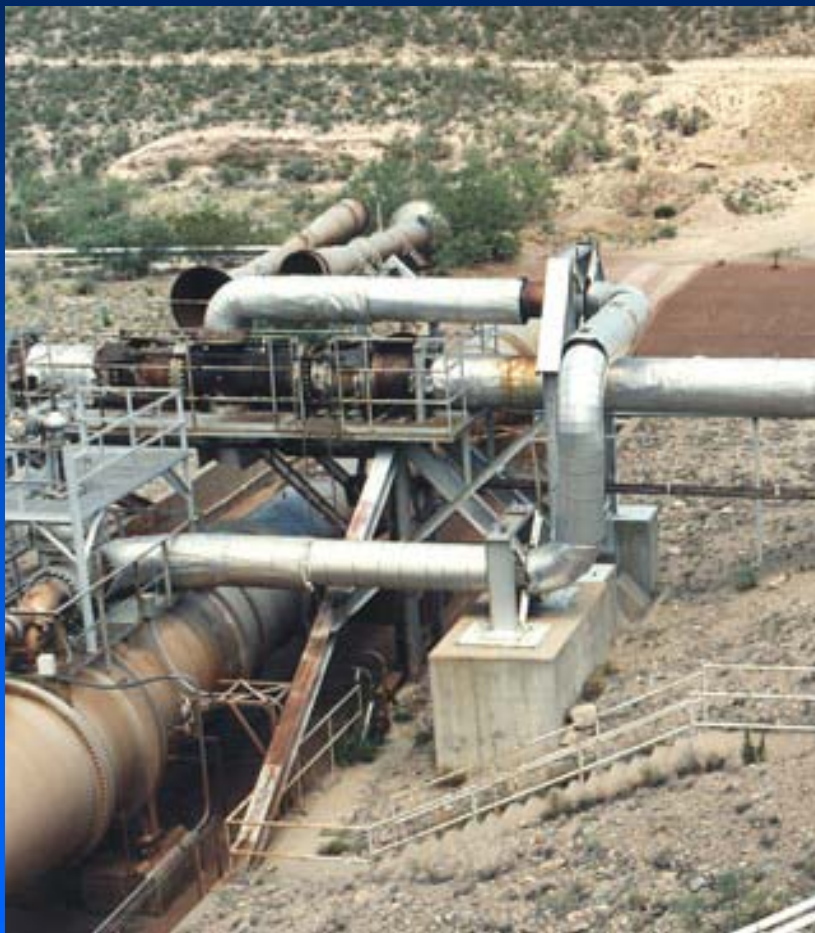
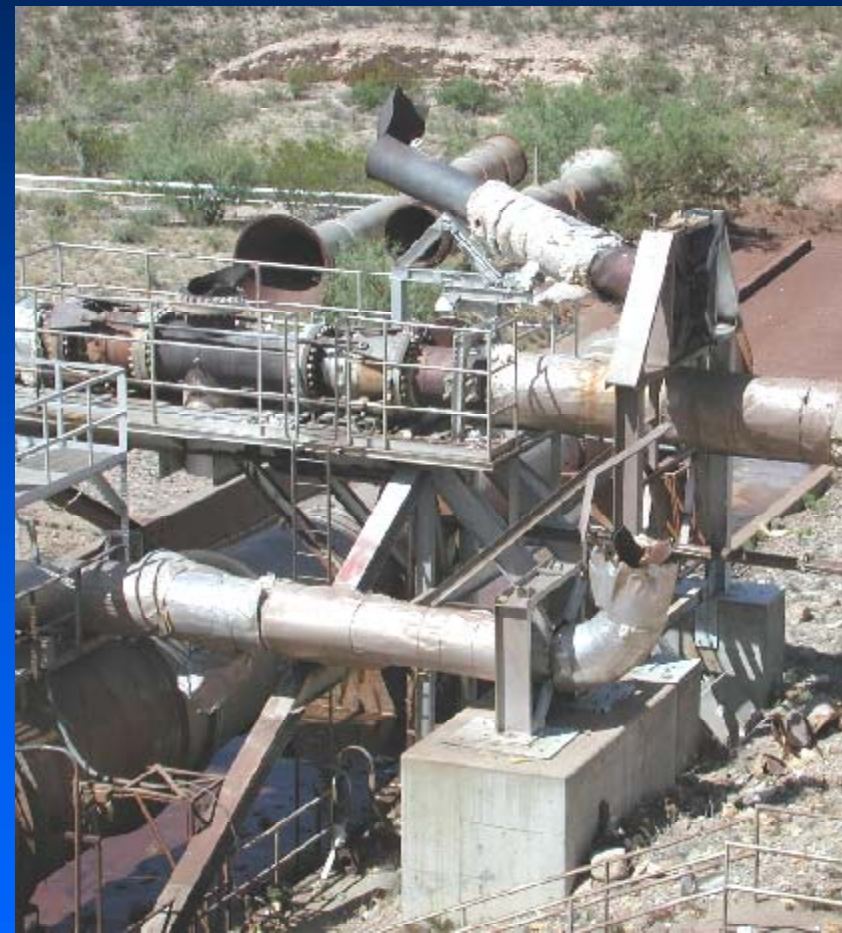
24 Inch Steam Line Expansion Loop Before & After

Before

After

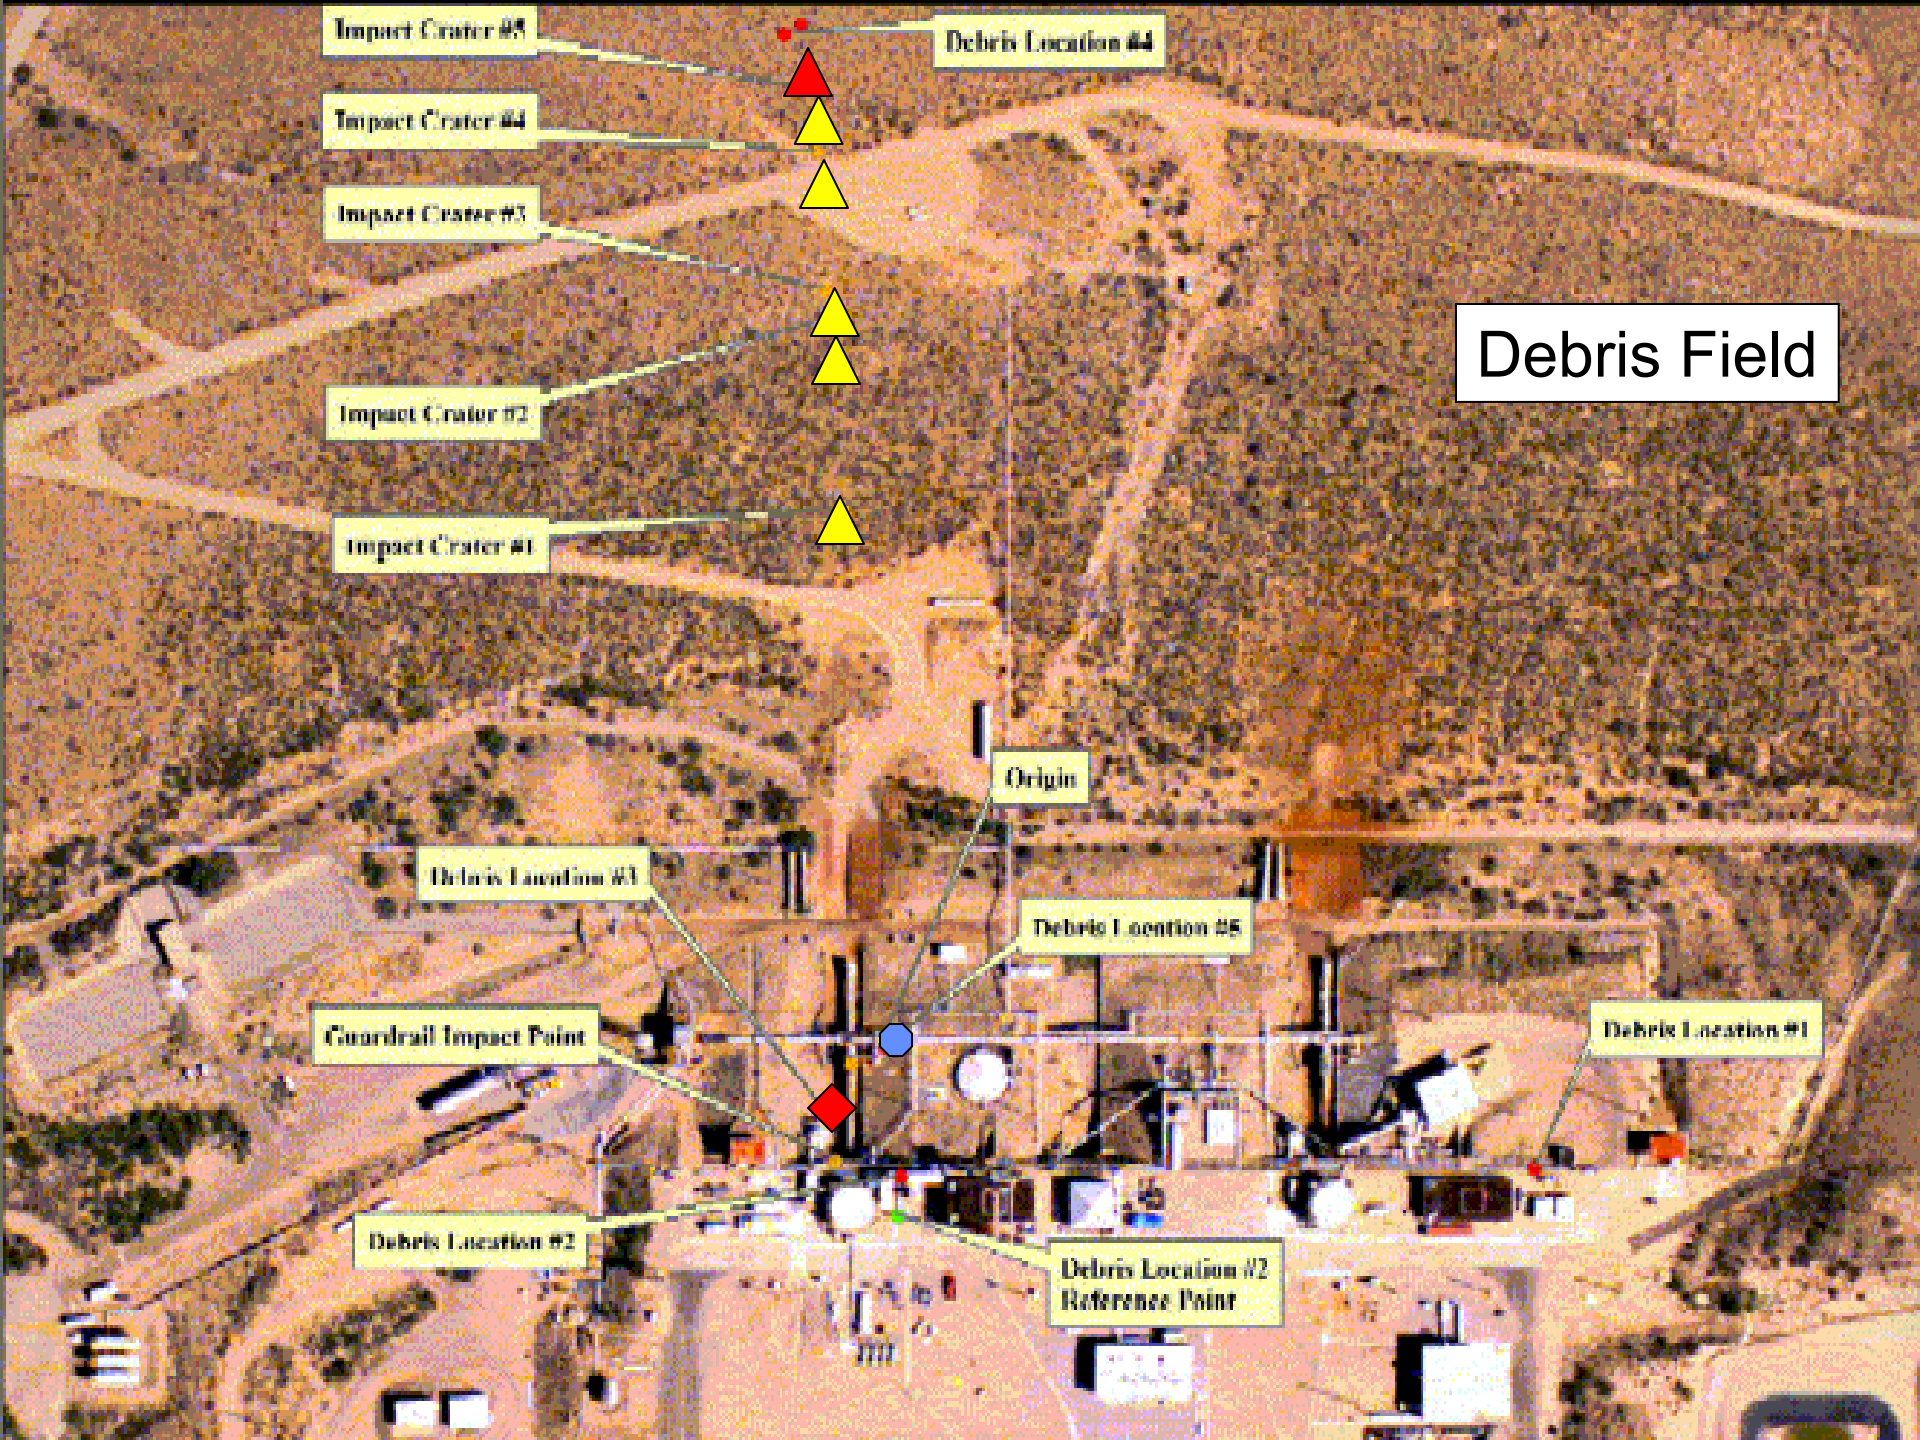
Debris Field

Origin

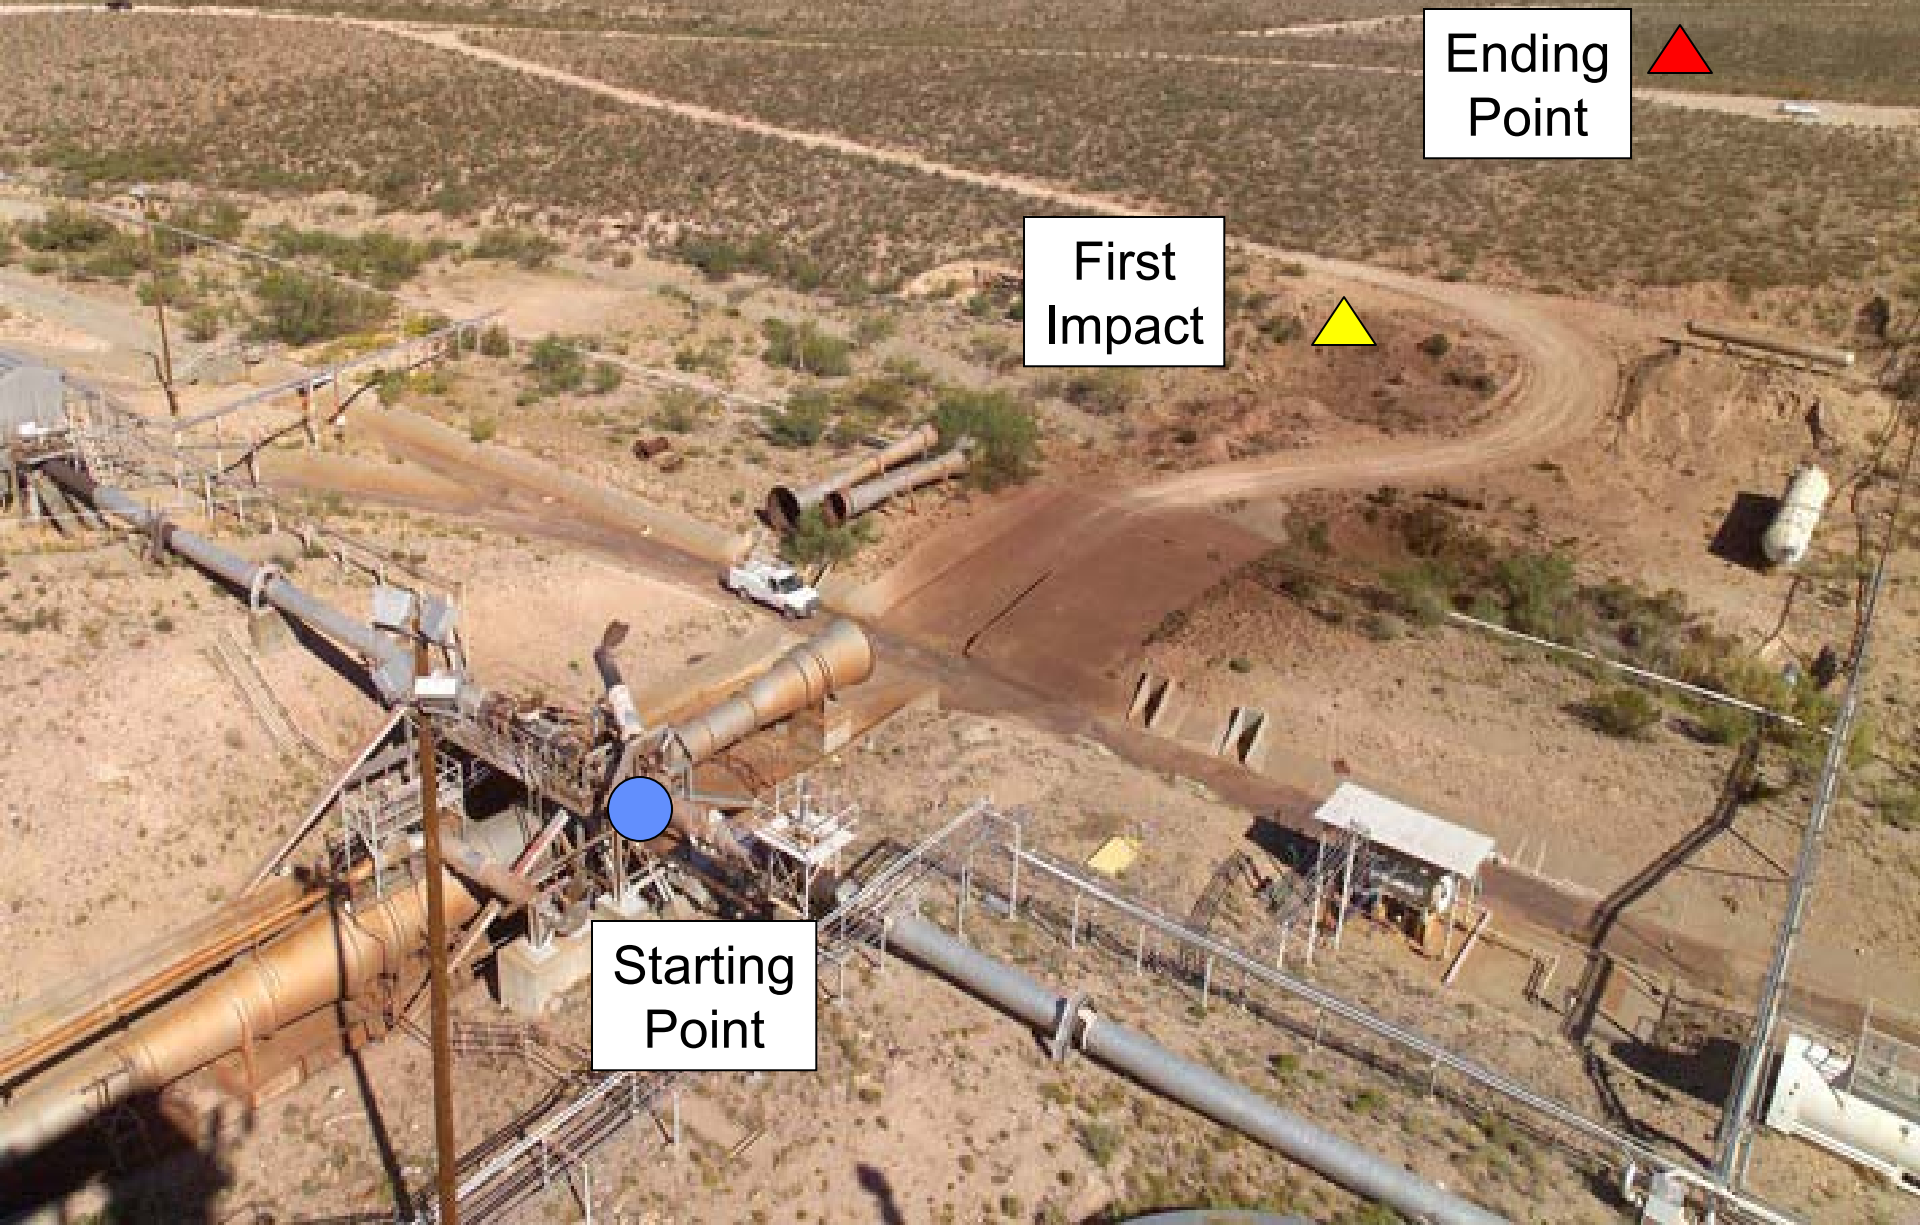
Desert Walker's Journey

Ending
Point

First
Impact

Starting
Point

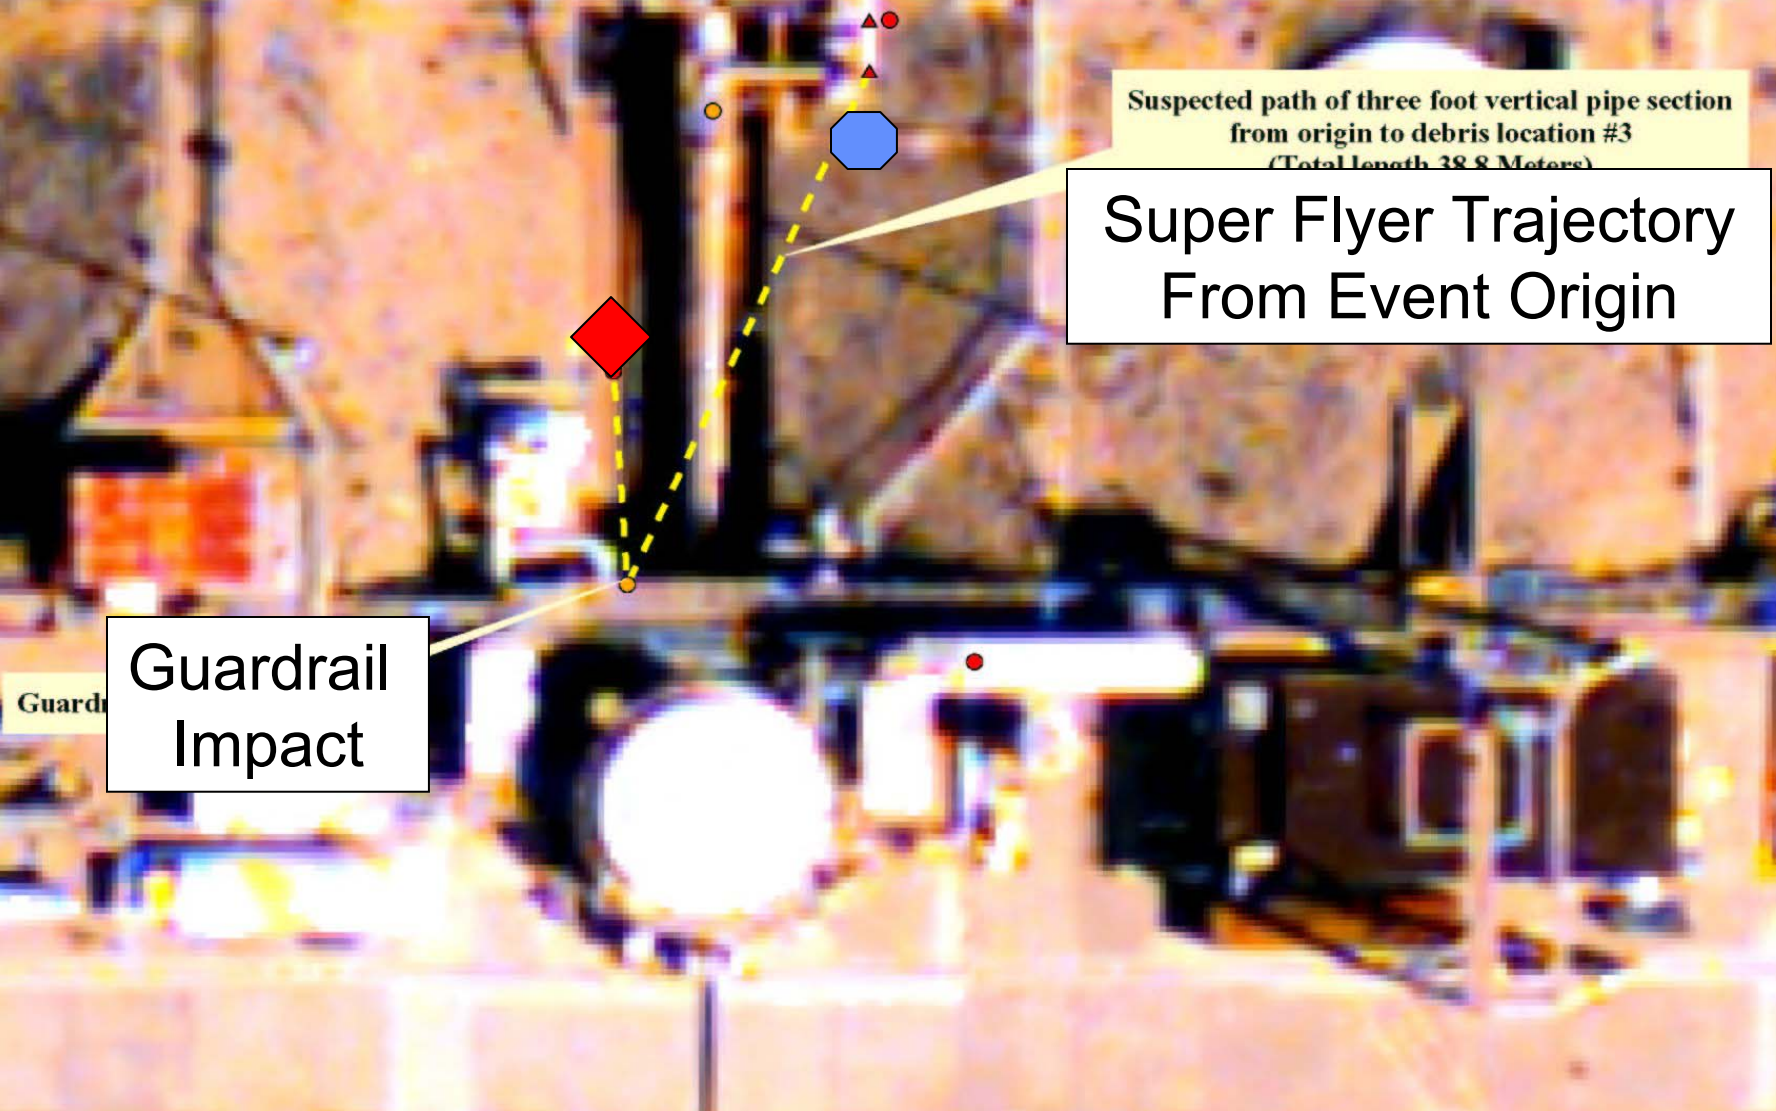
Facility Damage

Super Flyer Damage to Guardrail

Damaged Guardrail

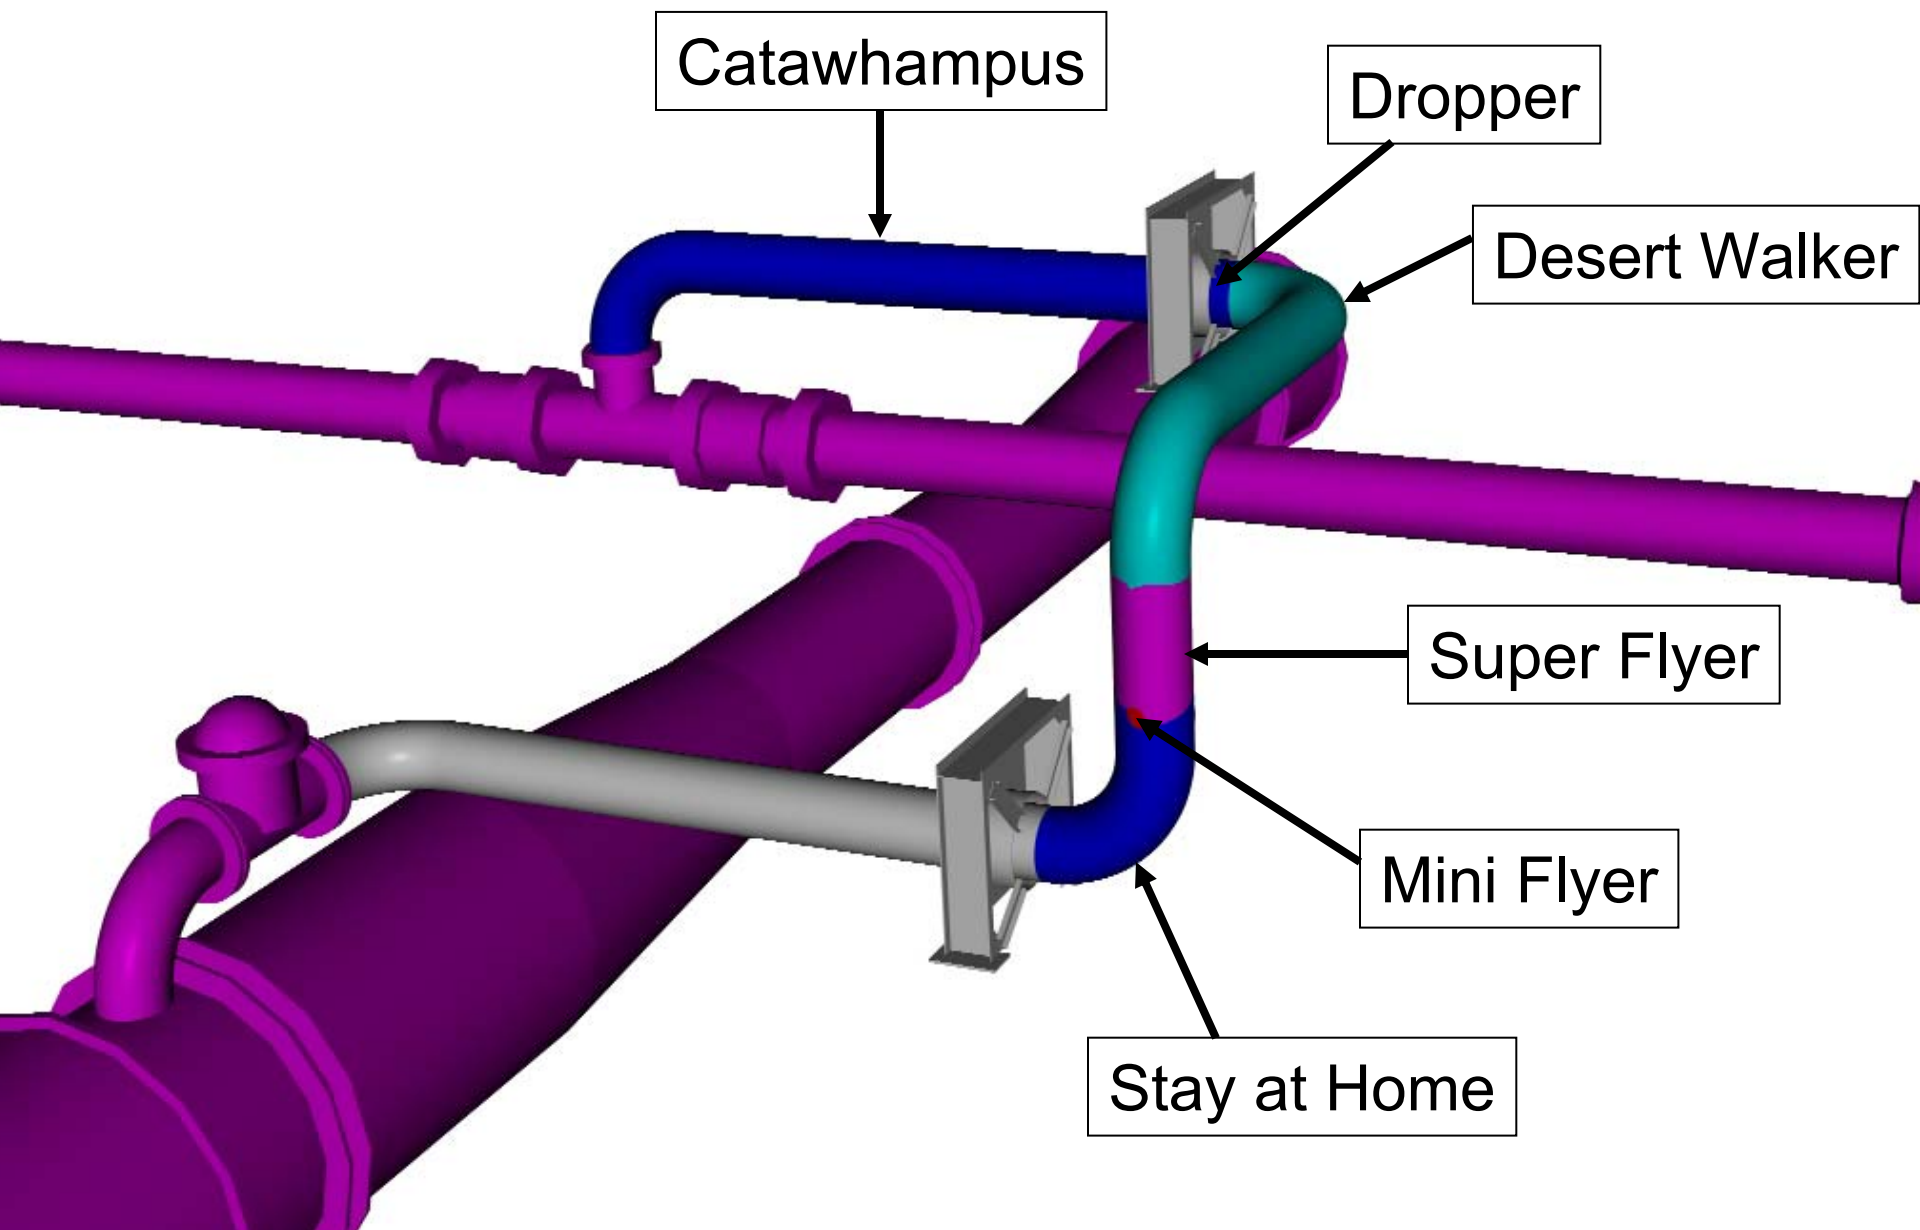
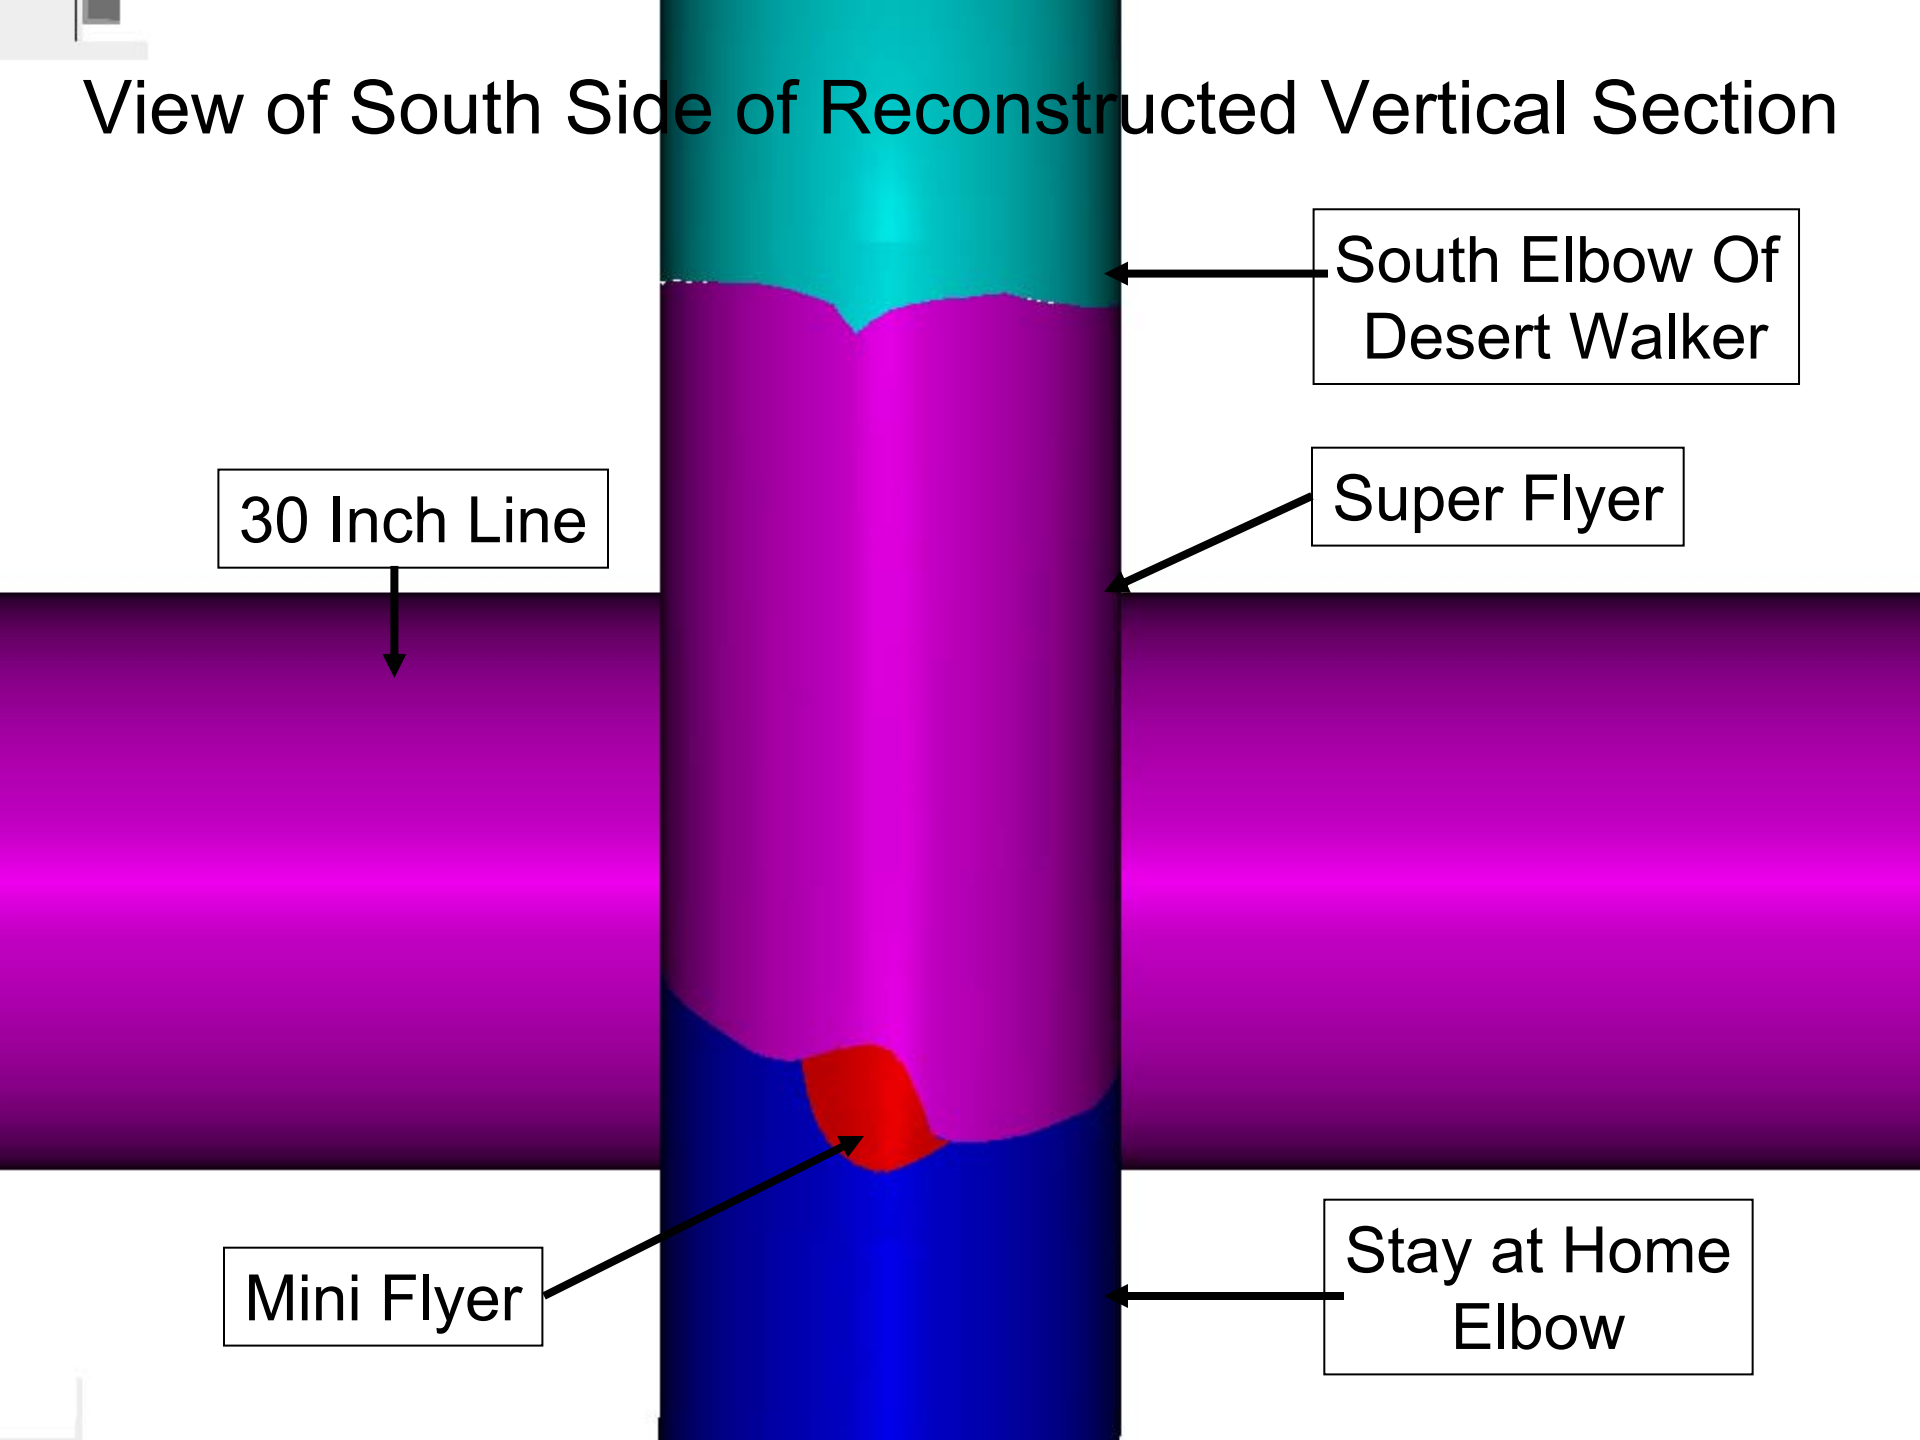
View of South Side of Reconstructed Vertical Section

Location of Rupture

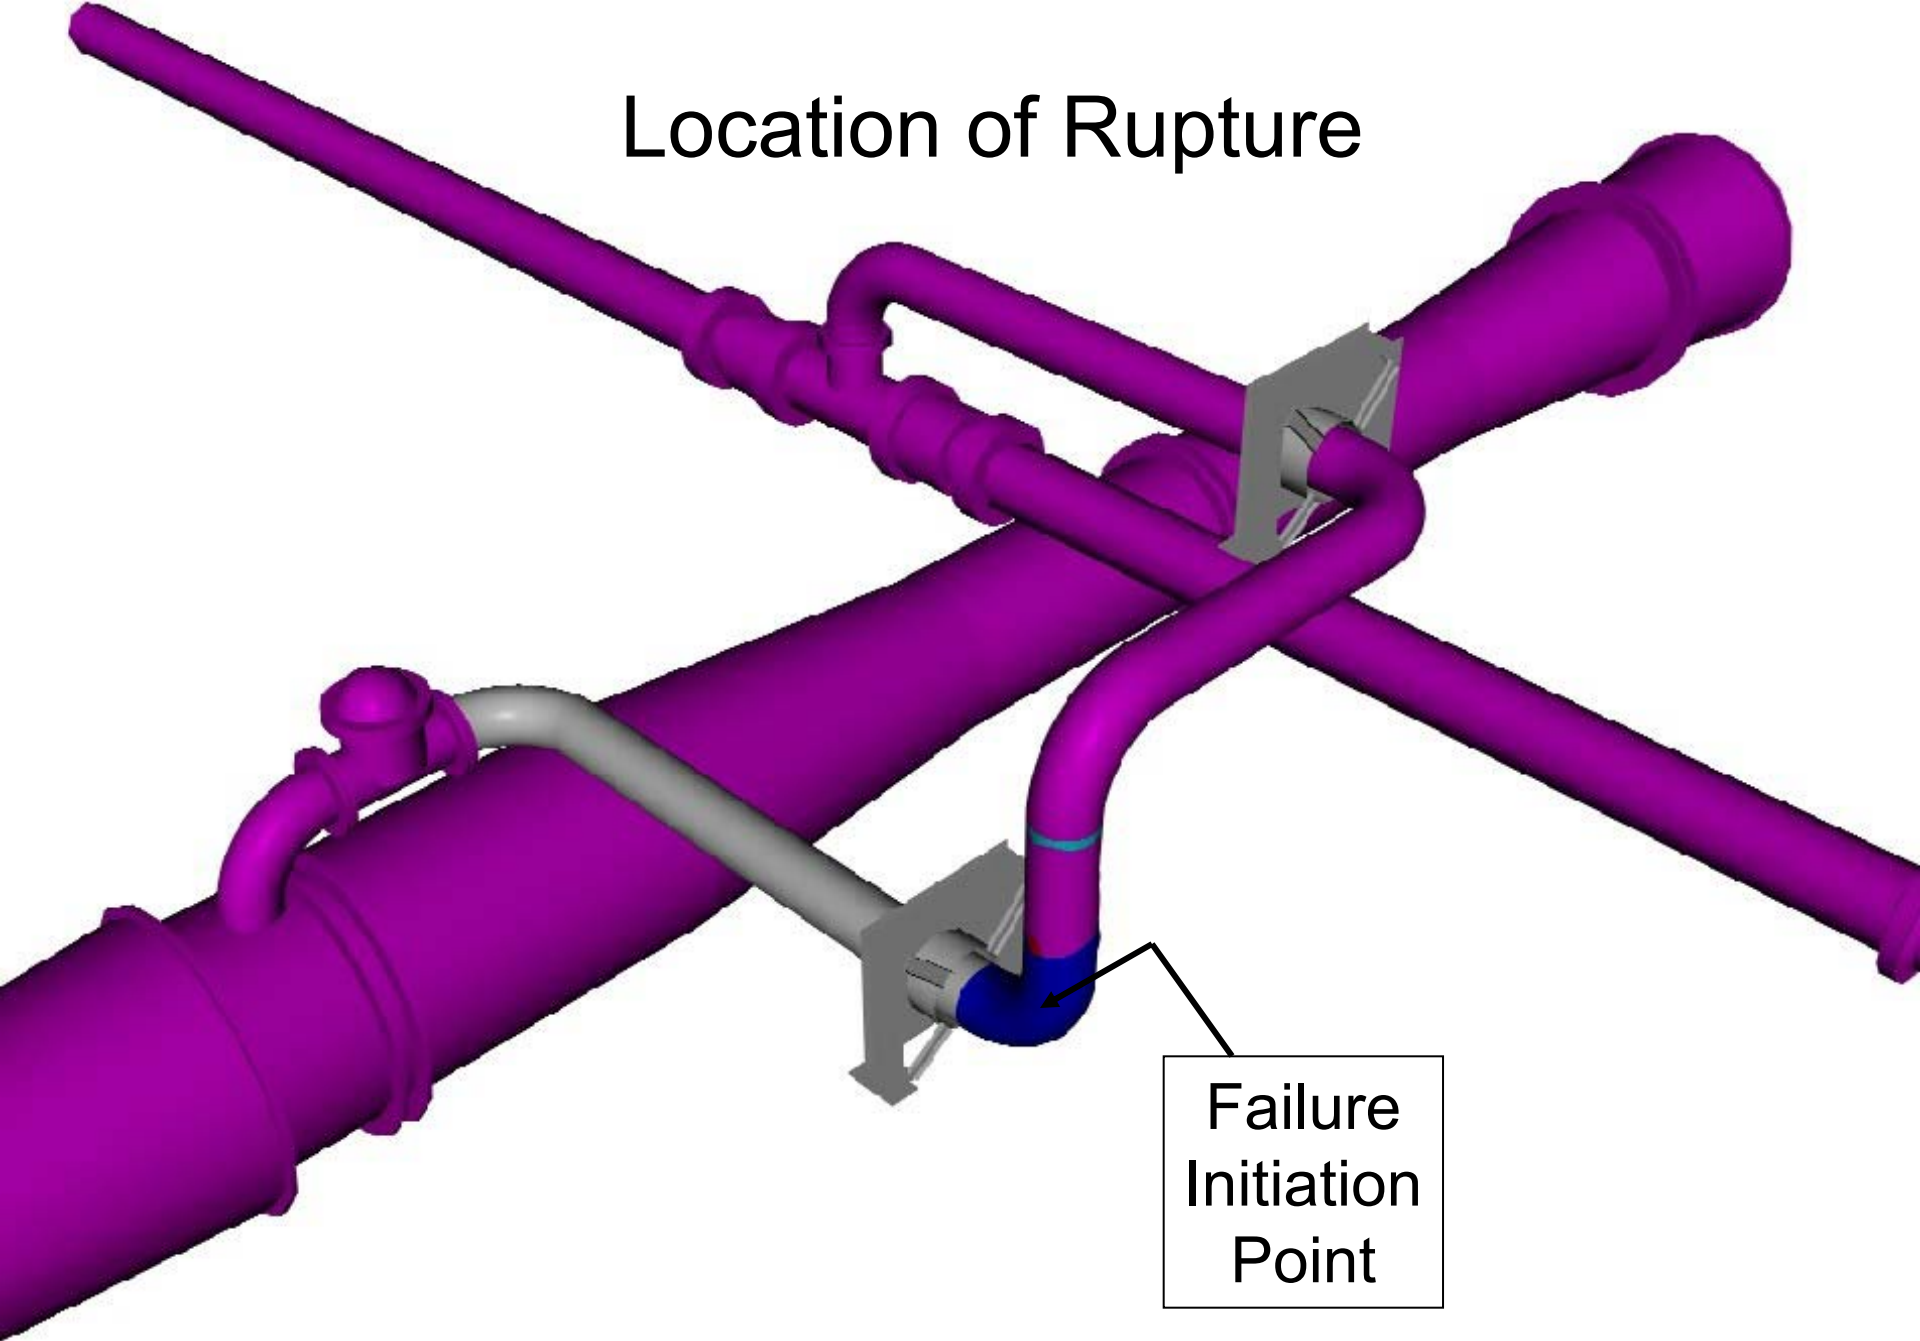
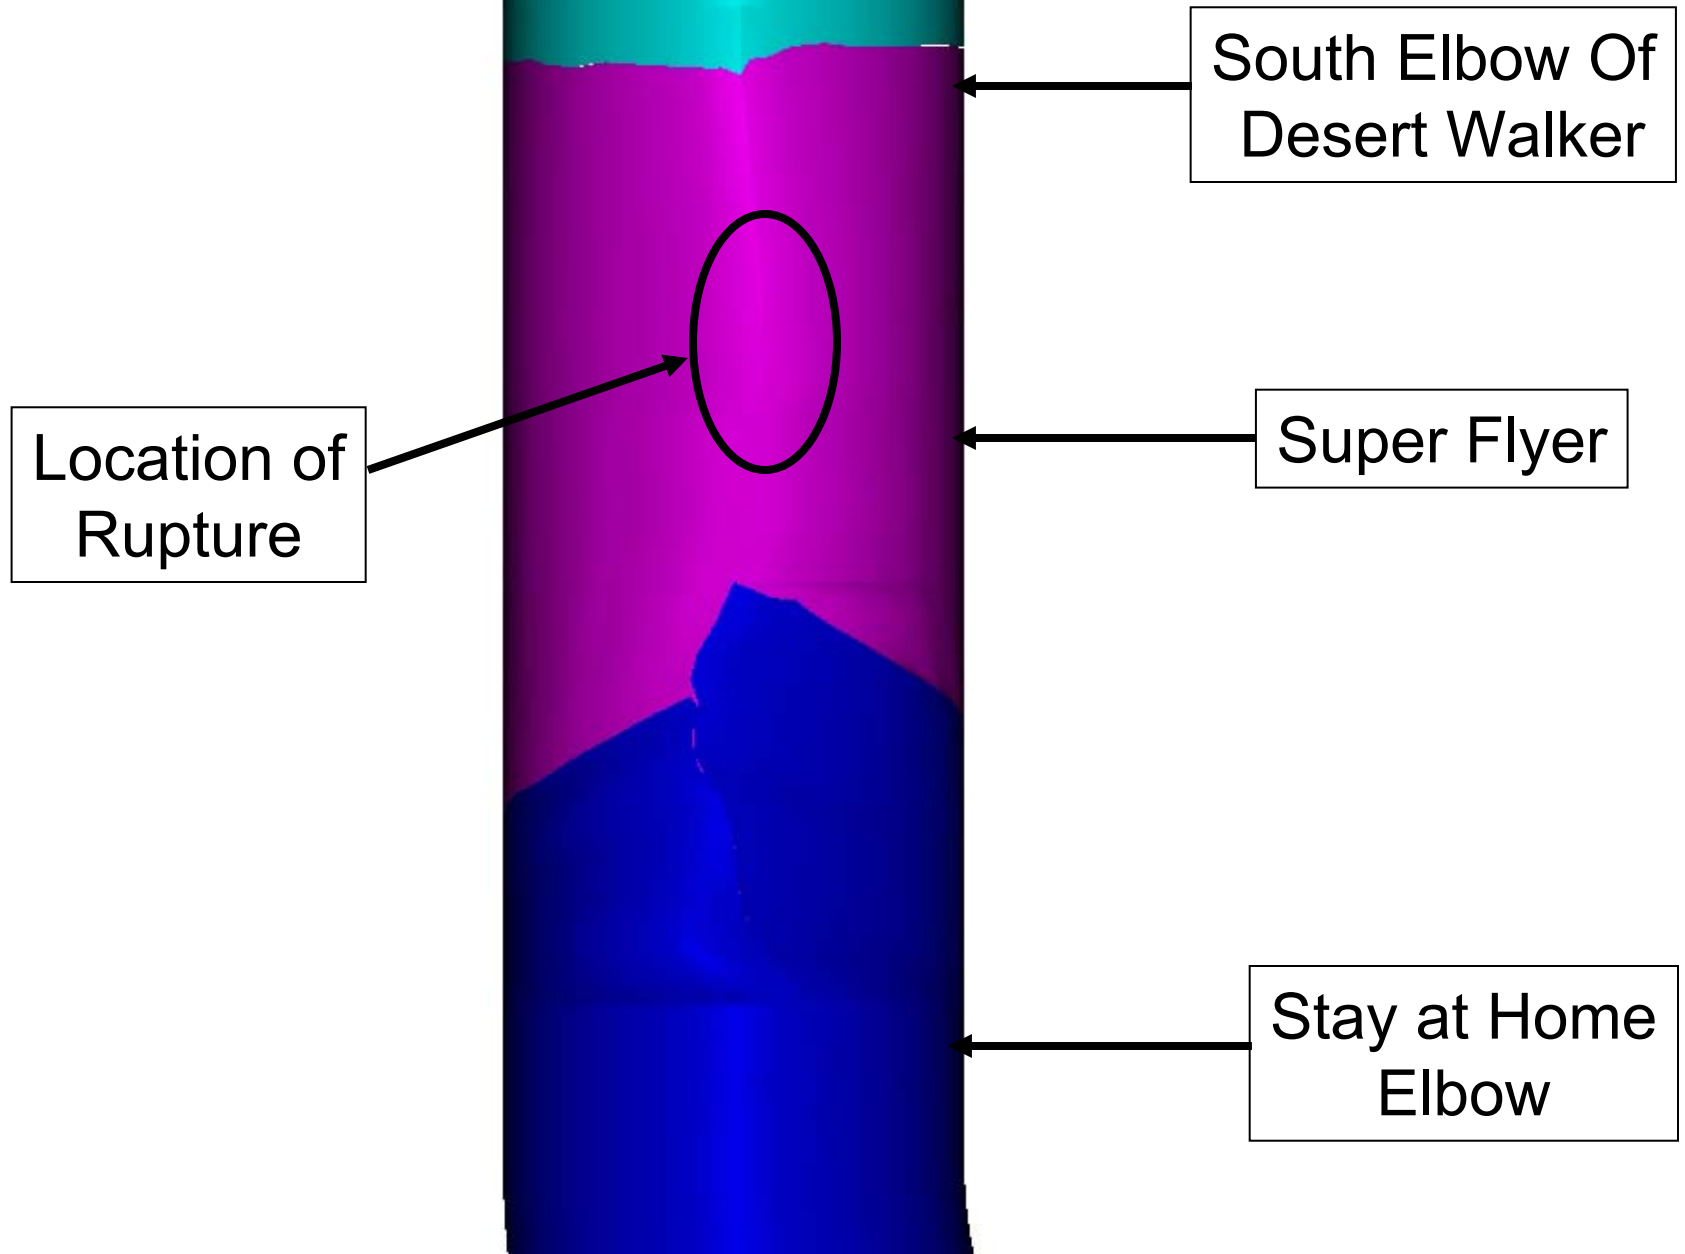
Failure
Initiation
Point

View of North Side of Reconstructed Vertical Section

Location of Initial Failure

Root Cause: Rupture of Vertical Section of 24" Pipe Due to Corrosion Induced Wall Thinning

- High Levels of Carbonic Acid in Steam
- Feed Water Not Treated
- Post Run Residual Water Not Drained
- LASS Configuration Led to More Thinning on North Side of the Vertical Section
 - TS 401 24" Valve Trapped Water
 - Diurnal Evaporation-Condensation Kept Wall
 - Vertical Section Subject to High Torsional Stress
 - Corroded Layers Broken Away Due to Erosion

- Establish the Design, Operation, and Life Requirements as a Basis for Corrosion Allowance
- Assure that LASS Does Not Retain Moisture in Steam Lines Between Runs
- Develop and Implement a Corrosion Survey Plan That Includes Trending and Pass/Fail Criteria
- Investigate Methods to Neutralize Carbonic Acid
- Determine Feasibility of Removing Insulation From Steam Lines to Reduce Exterior Corrosion

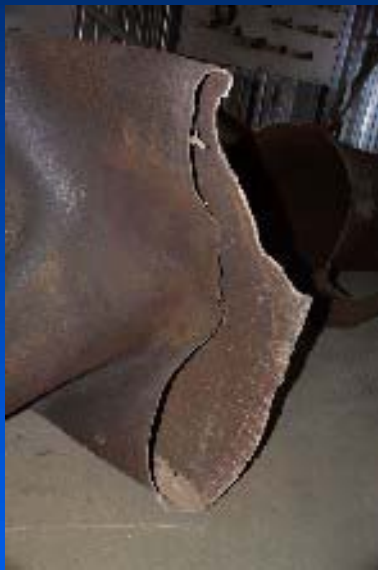
Upper Fracture
Arrest Area

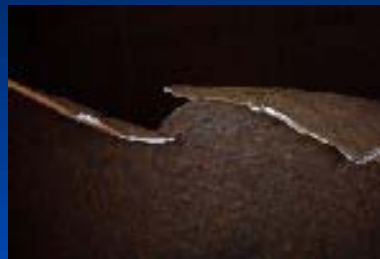
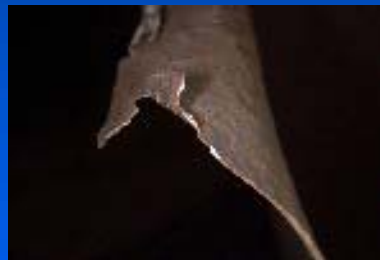
Thin Areas on
Super Flyer

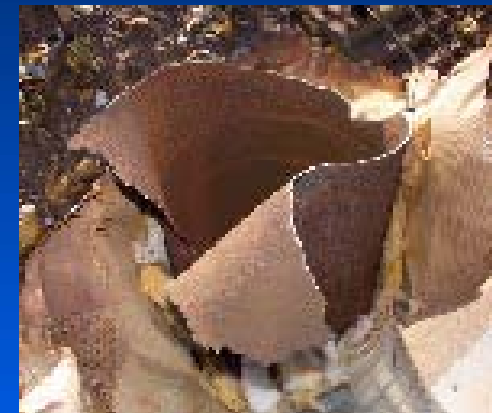
Lower fracture
Arrest Area
